## MAZDASPEED3/6 and MPS Service Bulletin

This Service Bulletin has been created to help keep you informed about properly maintaining your MAZDASPEED3/6 and MPS vehicle running the L3T DISI (Direct Injection Spark Ignited) engines. This bulletin will also keep you informed of some engineering short-comings from the factory that you may experience while modifying your vehicle and to keep you up-to-date with some extended service techniques that can be used to make sure that your vehicle is performing optimally at all times.

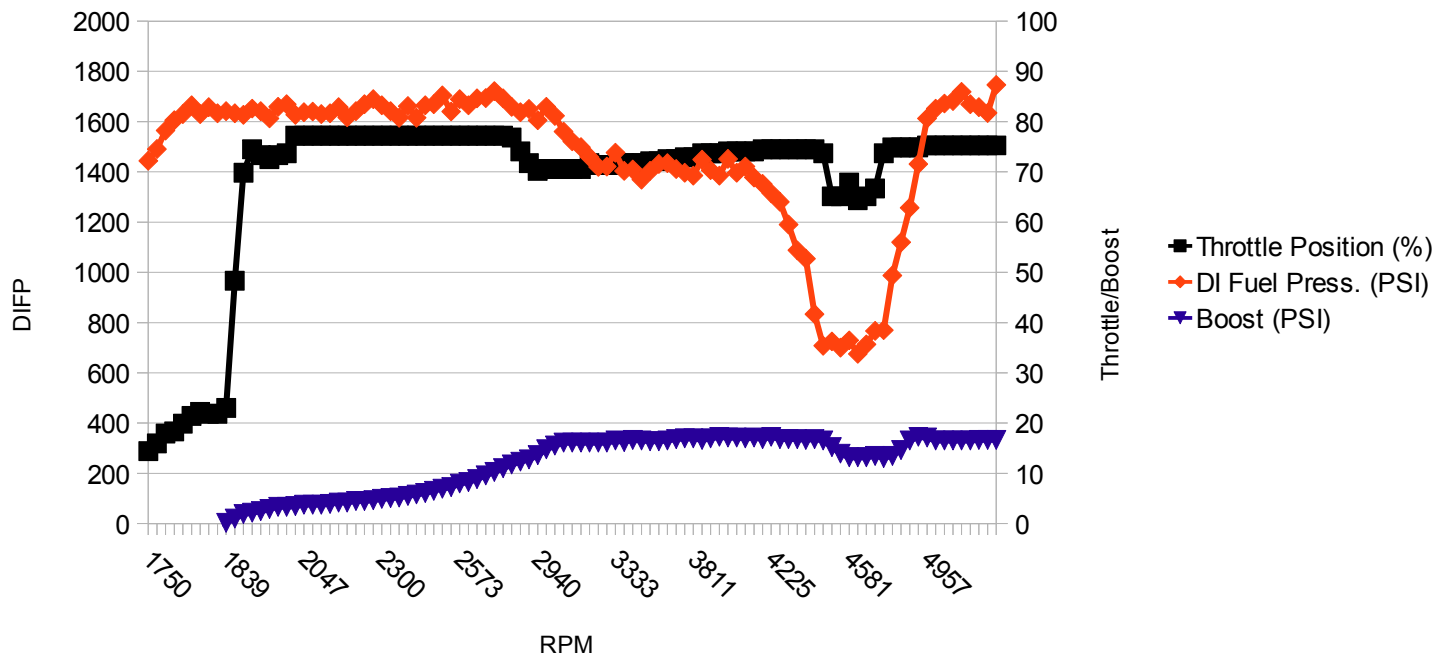
## Stock CDFP Failure

Below is an example of a datalog where one can see the stock CDFP failing during a Wide Open Throttle (WOT) run in 3<sup>rd</sup> gear. If this see this behavior with your vehicle, please switch to a Safe Mode calibration or cease running the vehicle hard until the CDFP can be upgraded.

The above graph is from the same datalog. Boost builds and holds steady at around 17psi across the RPM range, but starting at 3000 RPM, the DIFP starts to drop off, then continues to drop off severely enough that the ECU steps in and closes the throttle (lowering boost) to help limit torque production...and thus fueling demand. Once boost drops a few psi, the CDFP is capable of building enough pressure to achieve the DIFP targets and the ECU then allows the throttle to open fully once again.

Using AccessTUNER Race, you have a two strategies that can be employed (individually or combined) in order to work around this issue until an upgraded CDFP is installed.

- 1) You can incrementally lean out your WOT fueling targets to reduce fueling demands. This may not be possible with some lower fuel qualities since it may cause to lean (hot) of a combustion and Knock Retard values can increase when this happens.
- 2) You can incrementally decrease your WOT boost (or load) targets until you have the engine producing less torque, reducing fueling demands.

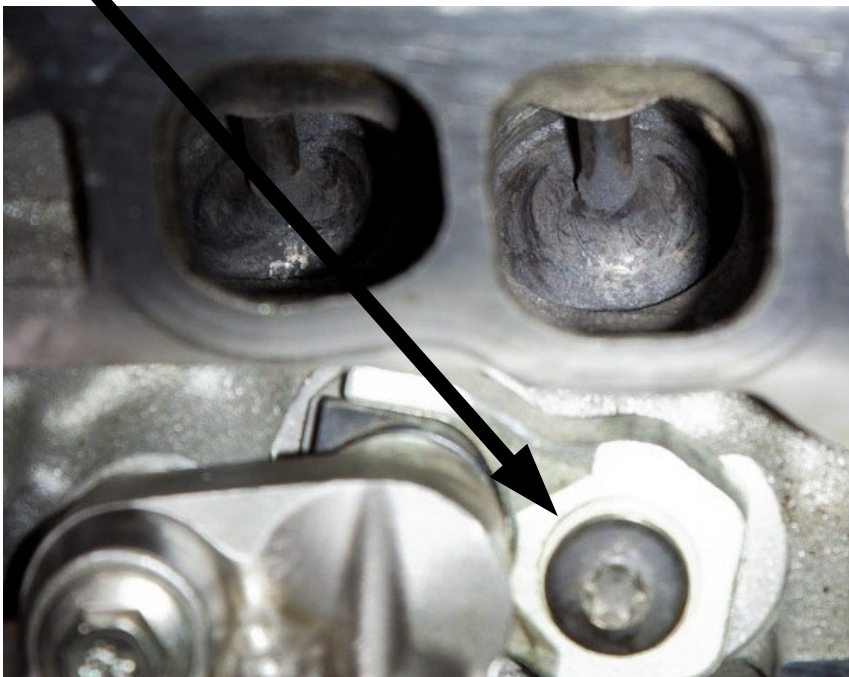
compression/combustion pressures. Each injector seats against an injector seal located at the bottom of the injector, deep within the head.

With each combustion cycle, these injectors are pushed up or compressed against the bracket and then seat back down on the seals and with time, the stock injector seals can become compressed allowing the DI fuel injector to rattle within the injector hole. The extreme heat being located so close to the combustion chamber also makes the stock injector seals brittle with time. This rattle is some times picked up by the engine's knock sensor and can be calculated as a knock event by the ECU. This is also known as false knock since the knock sensor is essentially a microphone designed to listen for noises within the frequency range of engine detonation or knock. The engine may not be detonating, but the DI fuel injector rattle can cause false knock which disallows the engine from running properly.

If you notice that your ECU is suddenly picking up more Knock Retard (KR) than normal, and you have ruled out all other common reasons for this (poor quality of fuel from your last fill up, excessive ambient heat, heat soak, rattling heat shield, etc.), then you may need to remove your DI fuel injectors in order to replace the DI injector seals located within the head. One good test for

false knock is to fill your fuel tank with 2-4 gallons of higher octane unleaded race fuel, around 100 octane will suffice. If the KR is still present, it's likely that your current DI fuel injector seals are failing or have failed. Several manufacturers offer after market alloy injector seals that are better suited for the higher temperatures and cylinder pressures realized by higher horsepower MAZDASPEEDs. If you plan on generating more than 350WHP or you notice a sudden change in your Knock Retard response, you may need to replace the stock DI injector seals. You can simply type "mazdaspeed injector seals" into your preferred web search engine and several options are available to you.

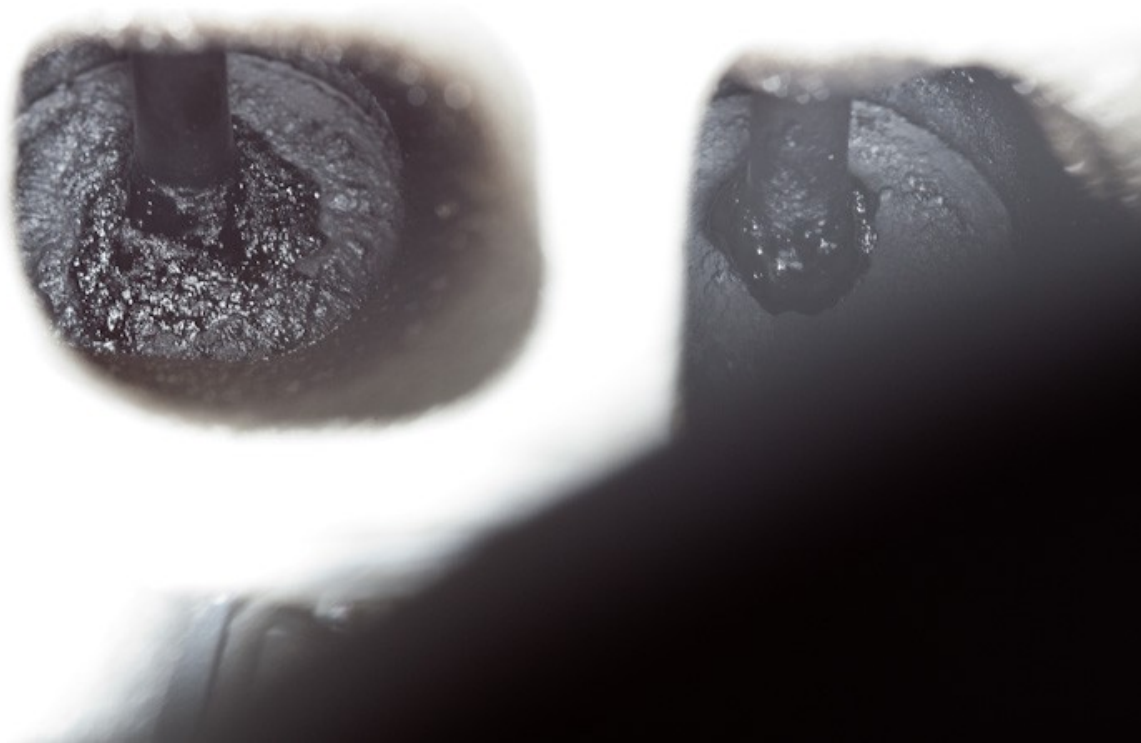
Cylinder #4

These pictures represent cylinder #s 4-2, starting at driver's side of the car and working to the passenger side, where the timing chain is located. Although, as you can see, the intake valves

for the cylinder closest to the Exhaust Gas Recirculation (EGR) port, pictured above, have the greatest amount of carbon build up. This carbon build up is more common with DISI engines since a fuel injector is no longer located in the port, firing above the intake valves in order to help wash the carbon off of the valves. It can be assumed that the closer in proximity to the return for the EGR system, the greater carbon build up on the intake valves will occur.

The valves in this port were the only of the 8 individual ports on the vehicle that showed a thick, gooey type of carbon build up as opposed to a dried/charred looking carbon build up exhibited on the intake valves of the other three cylinders.

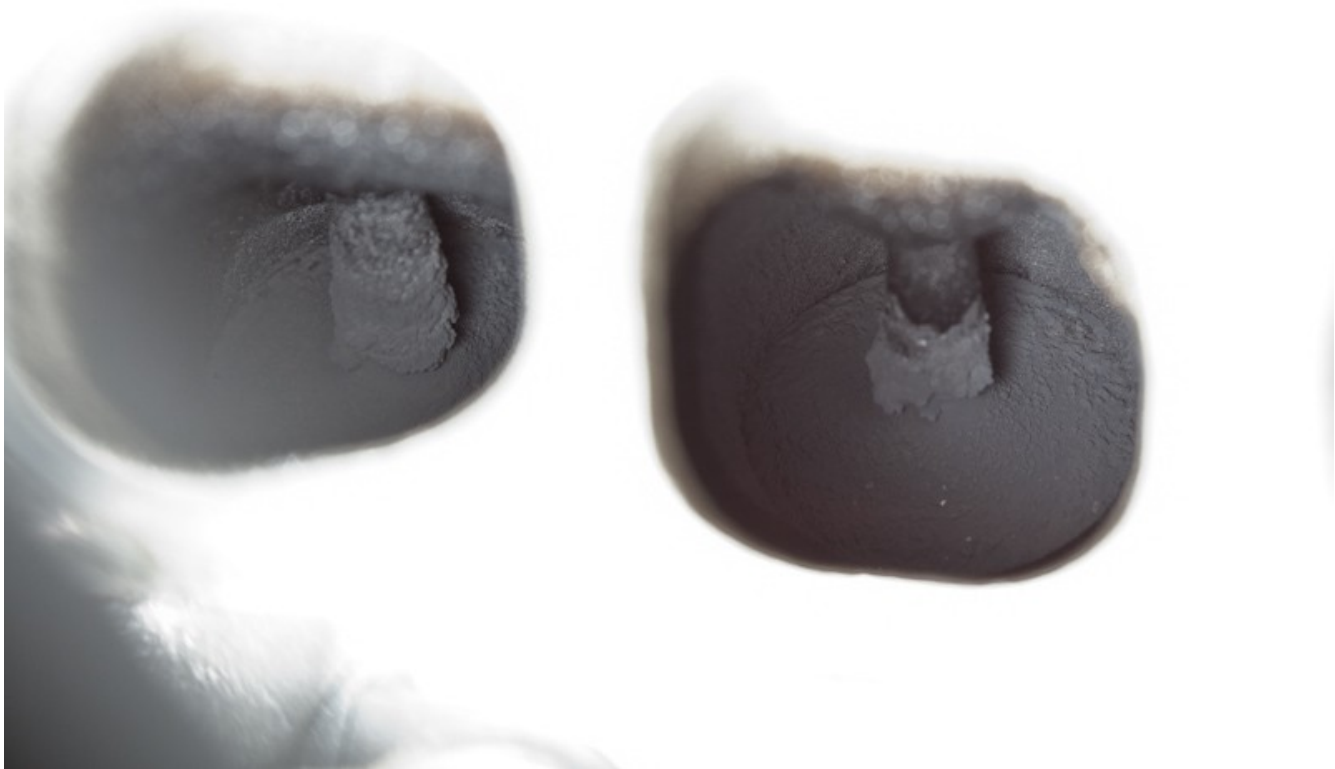
Cylinder #3

Less gooey carbon is present on the intake valves for this cylinder, but the carbon build up is still significant and unexpected for such low mileage.

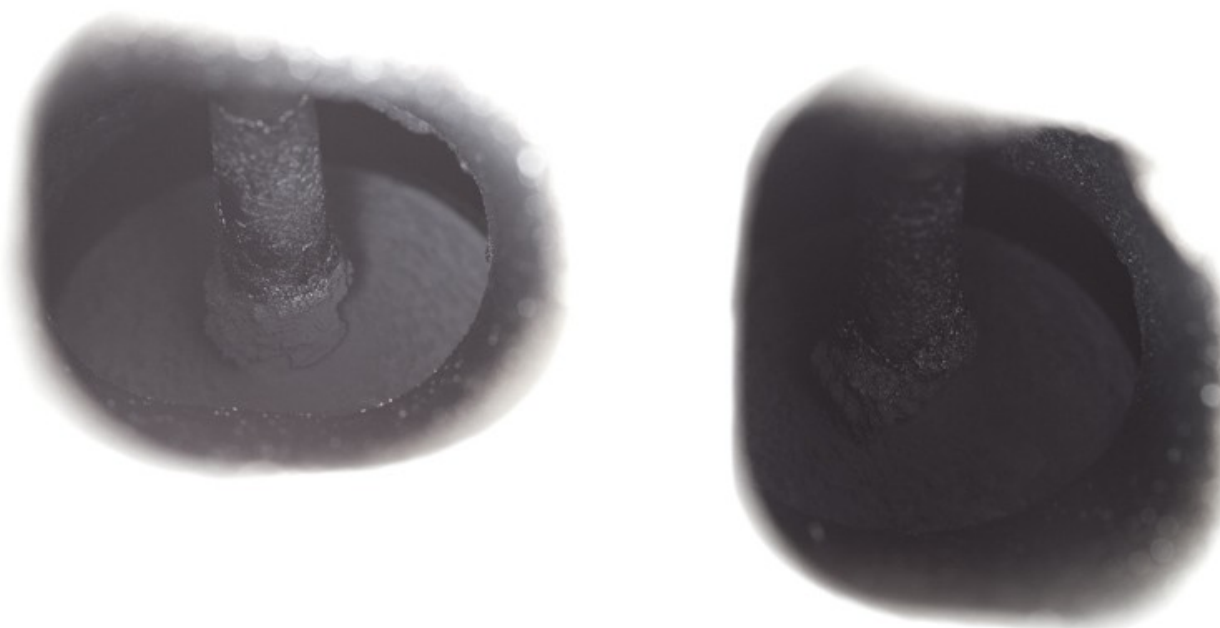
Cylinder #2

Unfortunately, we managed to not capture a picture of the #1 cylinder before the cleaning. As we mentioned, the carbon build up was less intense on the cylinders that are located further away from the EGR return.

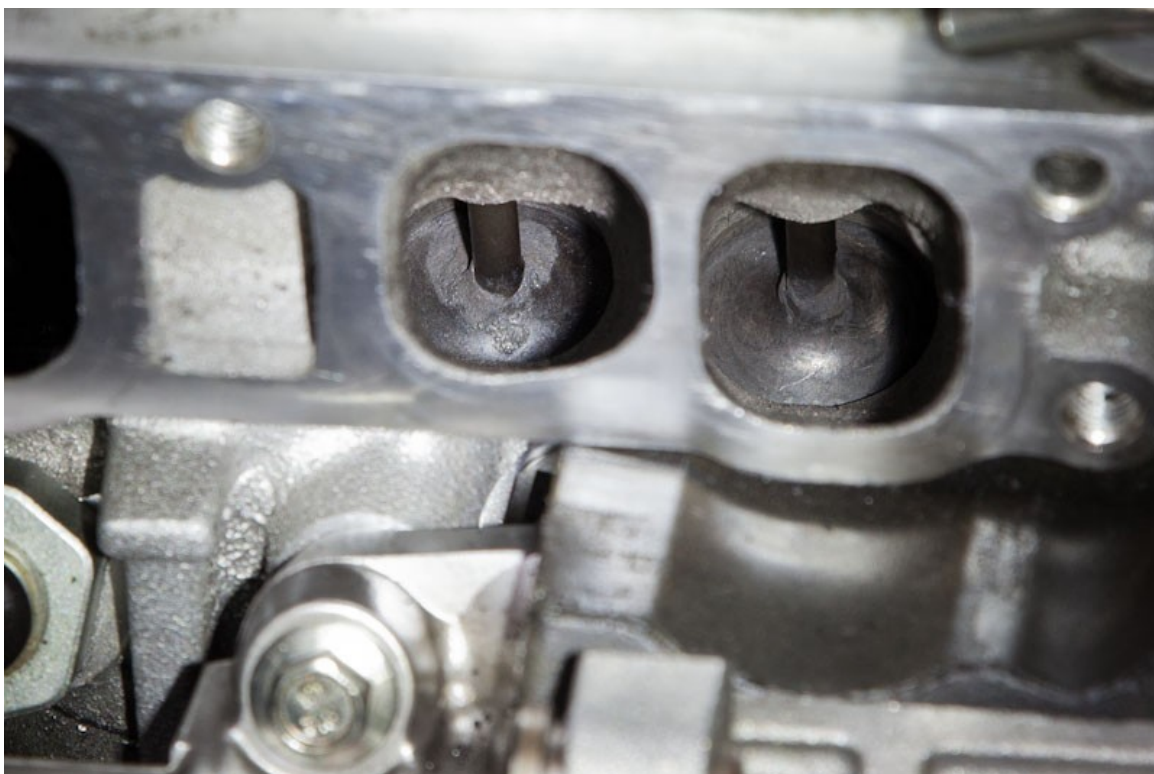
Cylinder #4 After

After the car was put back together and started, it was immediately noticeable that a smoother idle was achieved. We also noticed that the engine was clearly breathing better due to the +18% LTFTs that were present after the cleaning. The MAF calibration curve had already been dialed in perfectly.

While in the end, the valves in no way resemble a new part, we can state that they were sufficiently clean for the task at hand. We were able to remove a large majority of the hard and soft build up on the valve surface, leaving only the most stubborn of buildup remaining. If more time had been allotted, we are confident that the remaining buildup could have been removed. Longer soak times and more diligent cleaning would also help remove the built up carbon. The more soaking and scrubbing time you a lot to this job, the cleaner the intake valves will get.

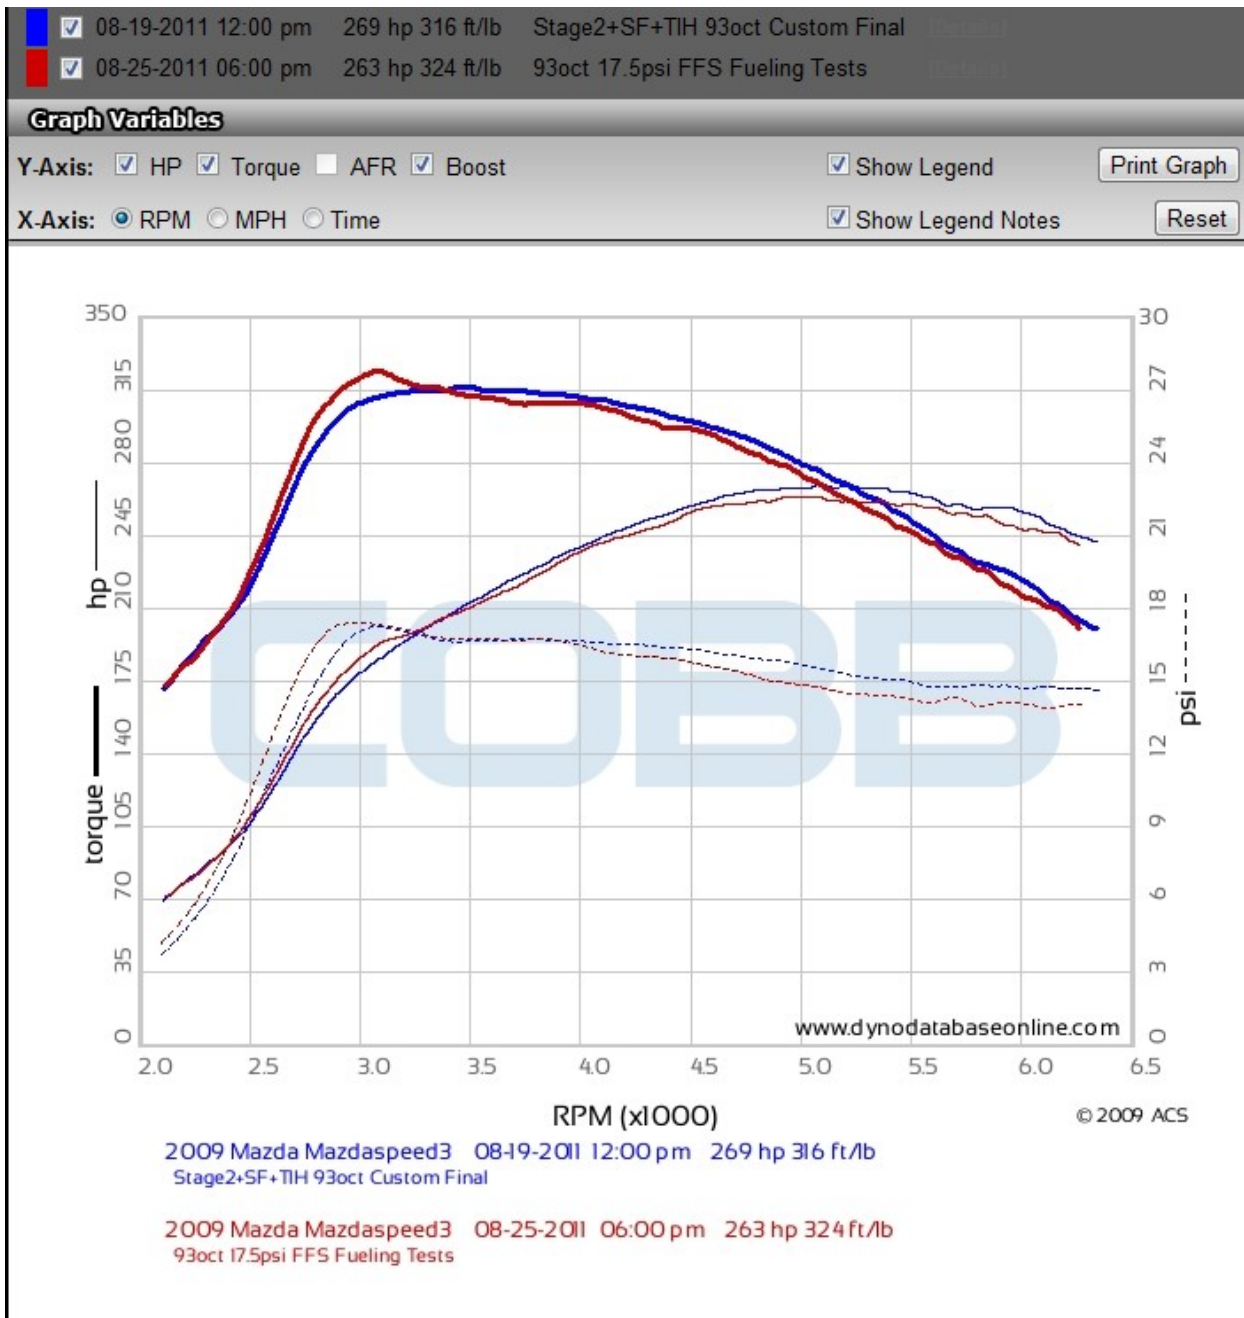
The above dyno graph is the before and after intake valve cleaning comparisons on the same vehicle running the exact same tuned calibration. The “before” runs (blue) were done in the morning in approximately 90 degree temperatures. The “after” run (red) was done in the afternoon with 100+ degree temperatures.

While the numbers may appear to be inconclusive, you can see that we’ve gained more peak torque due to the ability for the car to reach boost targets at an earlier RPM range. The power and torque curves appear very similar, however those levels were achieved even though ambient air temperatures were 10-15 degrees warmer and boost levels tapered off more above 4000 RPM. The greater flowing intake valves actually run lower boost on the same Wastegate Duty Cycle (WGDC) values. Remember, boost is a measurement of restriction, or how much air is NOT getting into and out of the engine. The carbon build up on the intake valves was effectively decreasing engine airflow and creating more flow restrictions on the intake side of the head.
