| <b>Subject:</b><br><br>TRUNK LID REQUEST SWITCH INOPERATIVE - NO DTCs | <b>Bulletin No:</b> 09-023/07 |
| | <b>Last Issued:</b> 07/05/2007 |

## APPLICABLE MODEL(S)/VINS

2006 - 2007 Mazdaspeed6 vehicles with VINs lower than JM1GG\*\*\*\*7\*109258 (produced before Feb. 5, 2007) equipped with Advanced Keyless System

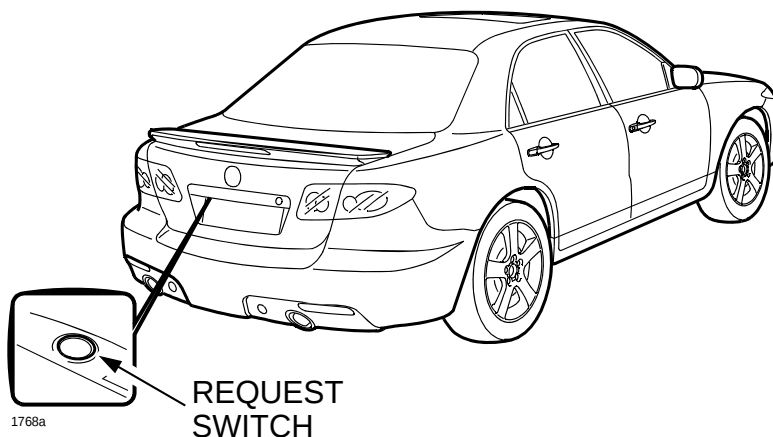
Some vehicles may experience an intermittent or inoperative trunk request switch operation, with no problems with the driver and/or passenger door handle request switches. This condition may be the result of water/salt entering the trunk lid request switch through the lead wires.

The request switch has been improved to prevent this concern by changing the sealing surface of the lead wires from a clear epoxy to a black urethane.

Customers having this concern should have their vehicle repaired using the following repair procedure.

- If trunk lid request switch PID does not change from On/Off when pressing and releasing the request switch, and no DTC's are present, replace the trunk lid request switch according to Workshop Manual (section 09-14 REQUEST SWITCH REMOVAL/INSTALLATION).

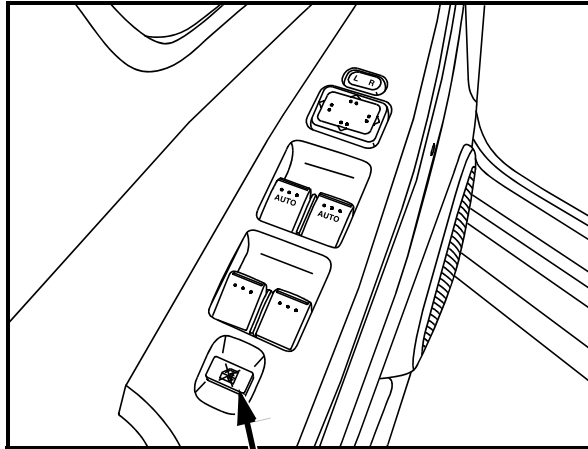
1601a

ENSURE WINDOW LOCKOUT  
SWITCH IS NOT DEPRESSED

1. Turn ignition to ON position.
2. From driver's seat ensure window lockout switch is NOT depressed.

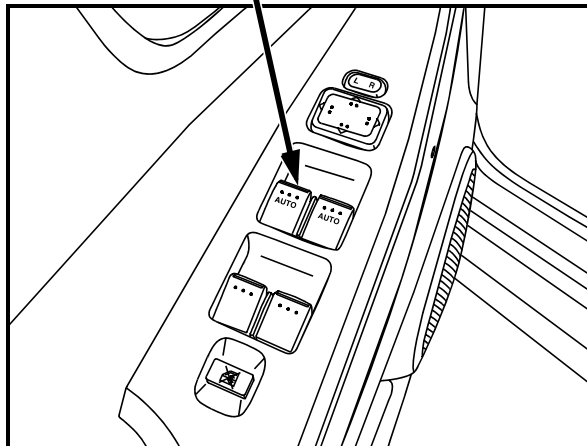
1601b

OPEN WINDOW FULLY, CLOSE WINDOW  
FULLY HOLDING SWITCH UP FOR  
TWO(2) SECONDS, RELEASE SWITCH

3. Press window switch down to fully open door window.
4. Pull window switch up to fully close door window; hold switch up for two (2) seconds; release switch.
