## MAZDASPEED3/6 and MPS Service Bulletin

This Service Bulletin has been created to help keep you informed about properly maintaining your MAZDASPEED3/6 and MPS vehicle running the L3T DISI (Direct Injection Spark Ignited) engines. This bulletin will also keep you informed of some engineering short-comings from the factory that you may experience while modifying your vehicle and to keep you up-to-date with some extended service techniques that can be used to make sure that your vehicle is performing optimally at all times.

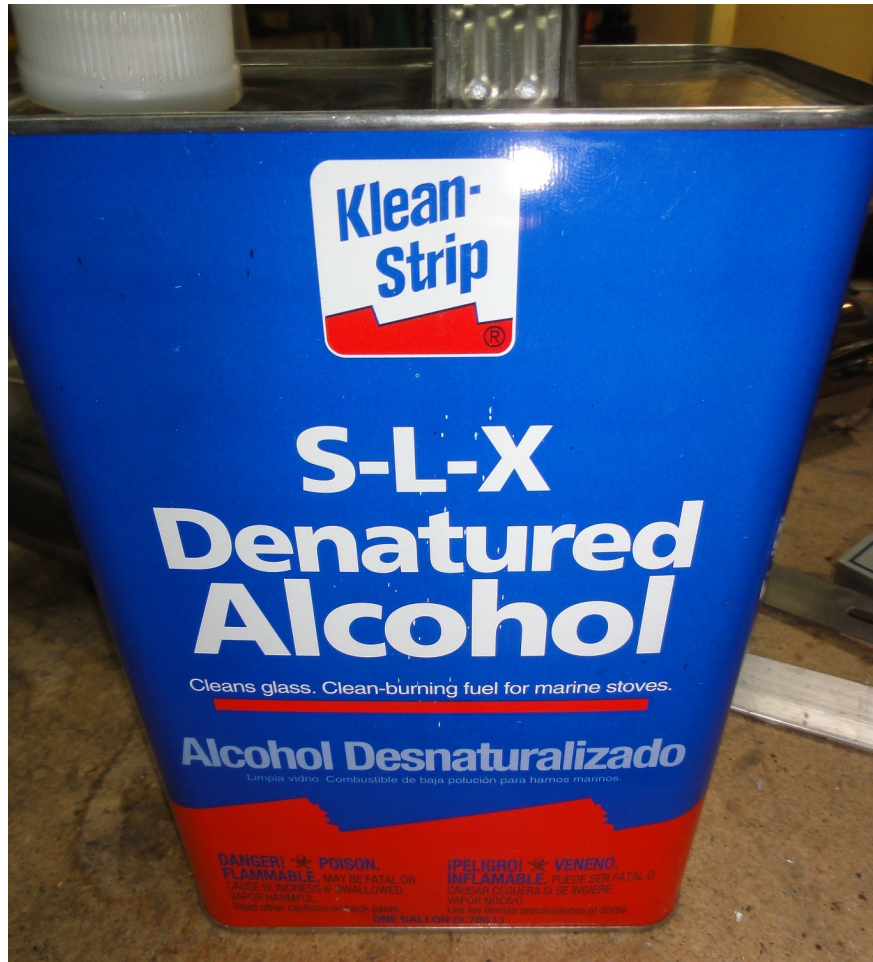
I. Denatured Alcohol - Had the strongest effect on the buildup and did the best job in turning the solution inside the port into a homogenous liquid saturated with the carbon build up. When scrubbed and siphoned away, the alcohol performed the best at removing the most buildup each subsequent "soak".

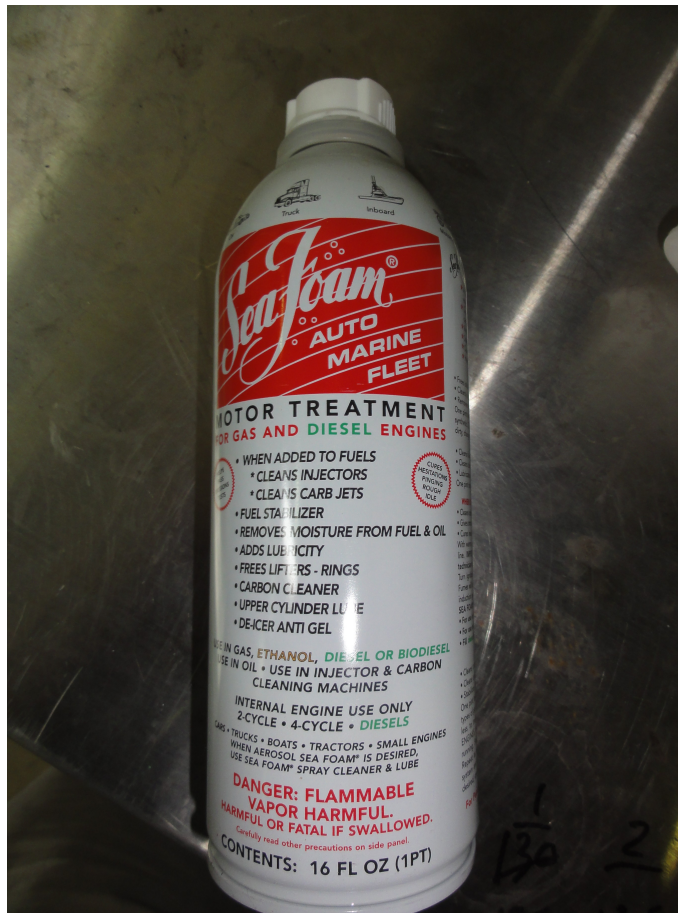
II. Sea Foam - Had a strong effect on the buildup but unlike the alcohol, did not dissolve the buildup as much as it broke it down into a removable “goop” that could be scraped away and removed from the port. Unlike any other solution, the Sea Foam allowed me to scoop up material that would stick to the tools.

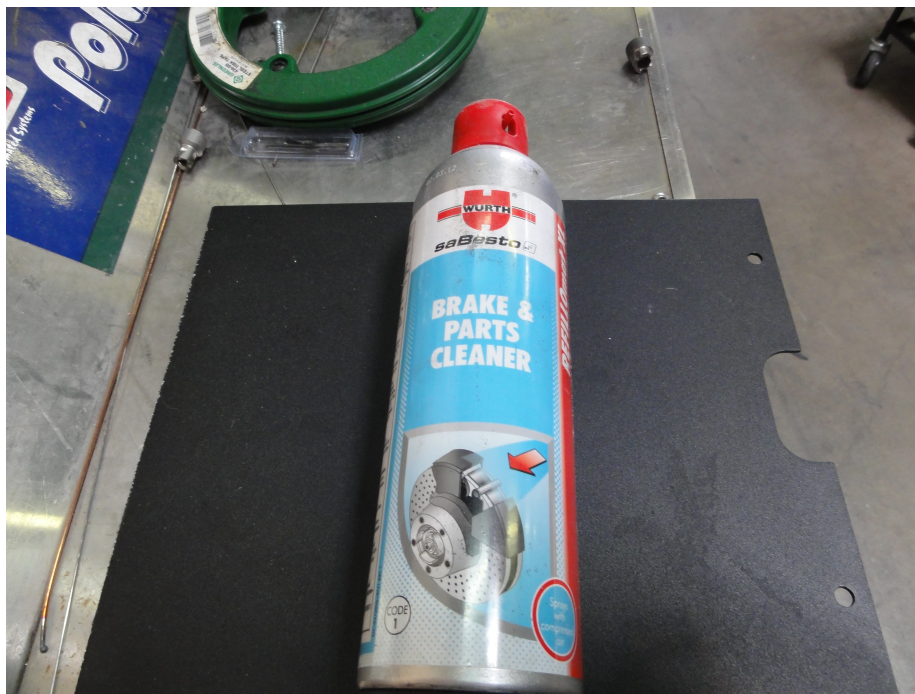
III. Brake & Parts Cleaner - While after soaking and scrubbing, the siphoned liquid from the port was obviously saturated with carbon material, the overall affect it had on the valve surfaces was

minimal compared with the alcohol and Sea Foam. The cleaning ability is similar to carburetor & choke cleaner.

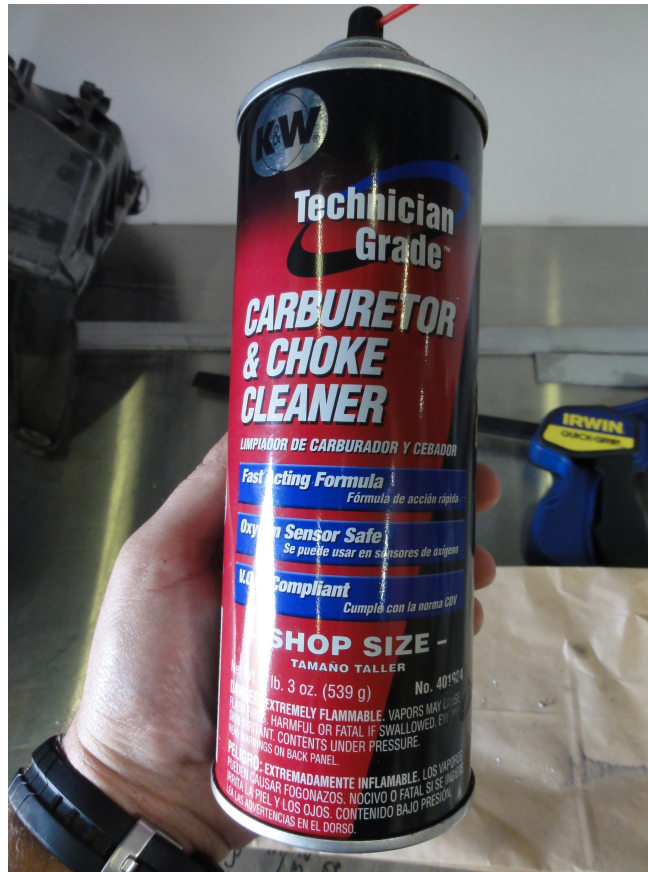
IV. Carburetor & Choke Cleaner - While after soaking and scrubbing, the siphoned liquid from the port was obviously saturated with carbon material, the overall affect it had on the valve surfaces was minimal compared with the alcohol and Sea Foam. The cleaning ability is similar to brake & parts cleaner.

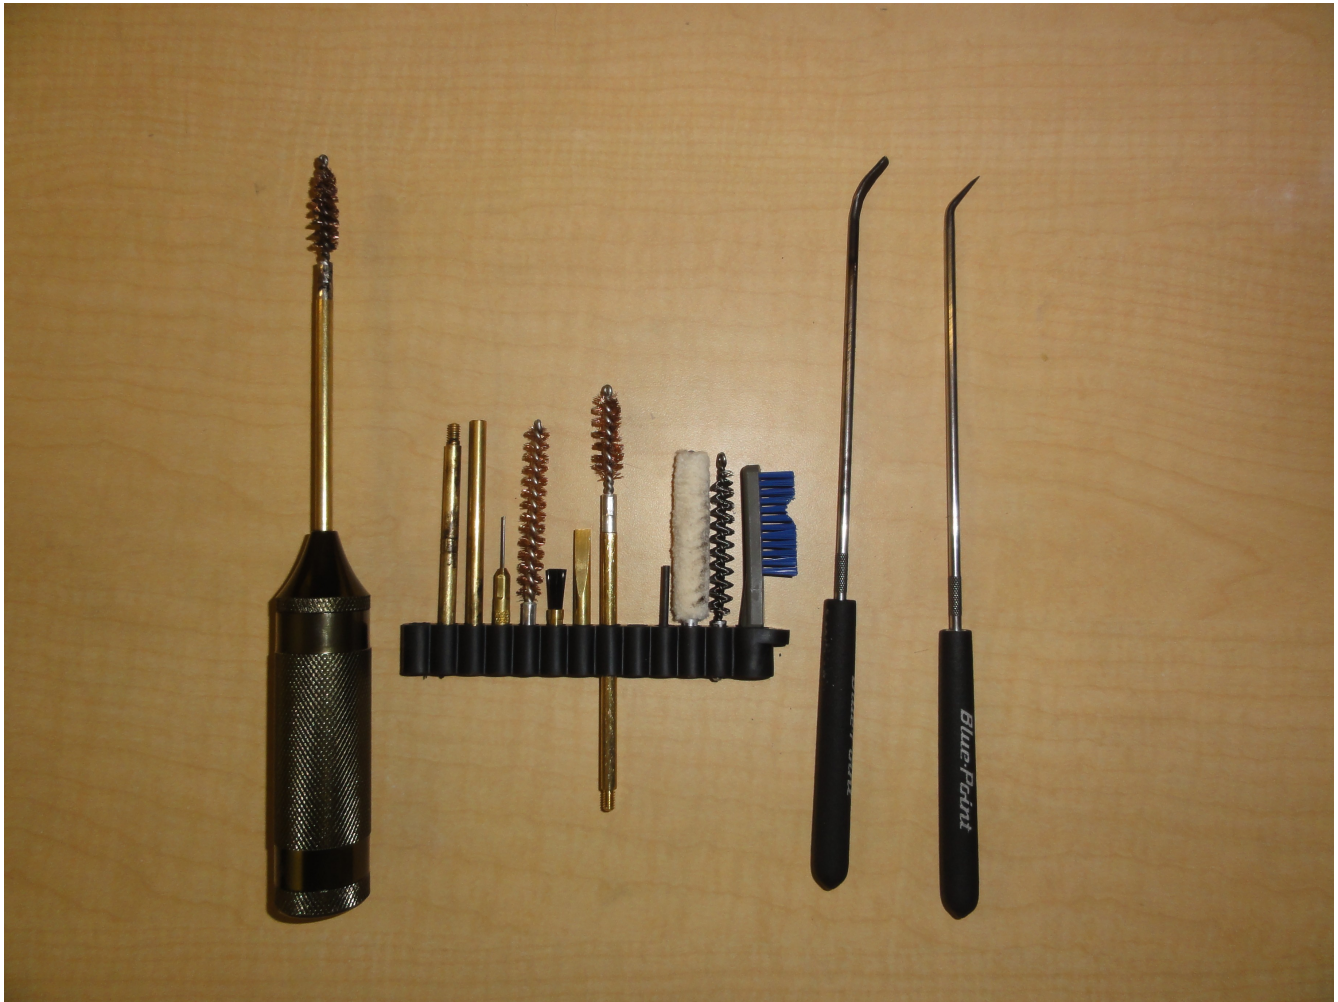
While in the end, the valves in no way resemble a new part, we can state that they were sufficiently clean for the task at hand. We were able to remove a large majority of the hard and soft build up on the valve surface, leaving only the most stubborn of buildup remaining. If more time had been allotted, we are confident that the remaining buildup could have been removed. Longer soak times and more diligent cleaning would also help remove the built up carbon. The more soaking and scrubbing time you a lot to this job, the cleaner the intake valves will get.

While we did not capture any “during” photos taken of each valve after their initial soakings; in the end, all the valve ports received at least 15-20 minutes of vigorous picking, scraping, and scrubbing with a combination of all the solvents. Please be sure to not scratch the valve shaft surfaces too far above the valve head as this is where the valves glide inside the valve seals and a scratched valve shaft surface may cause premature wear of the valve seal. This caution also goes for the bottom of the valve head where the precise machining to match the valve seat takes place.

To physically clean the valves, we used a combination of gun cleaning tools, consisting of various picks and wire brushes to agitate and remove the carbon buildup. The pick tool comes in handy when attempting to remove buildup on the back side of the valve. Some bending/flattening of your tools may be necessary to better accommodate the job.
